B-HCE Report Number 44-22003 – Pendant Properties, LLC Attachments

Photograph 39

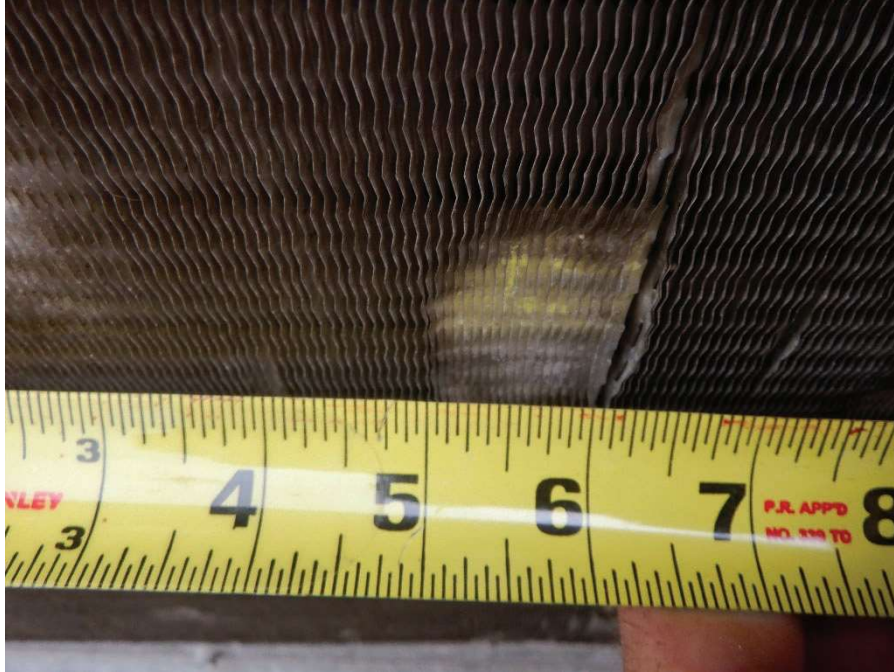
View of a shiny spherical hail-caused indentation approximately 1.2 inches in the north-facing condenser fins.

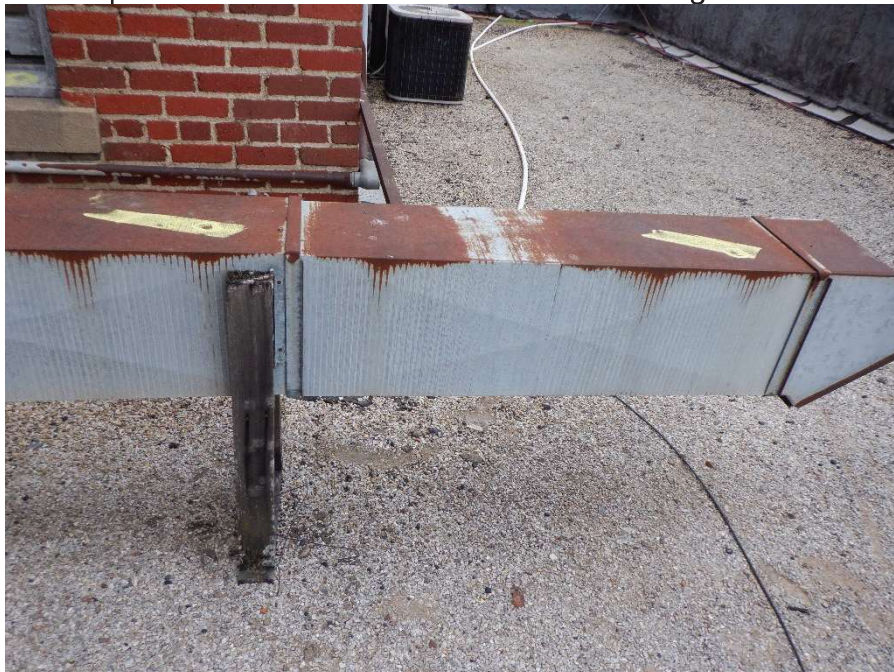
B-HCE Report Number 44-22003 – Pendant Properties, LLC Attachments

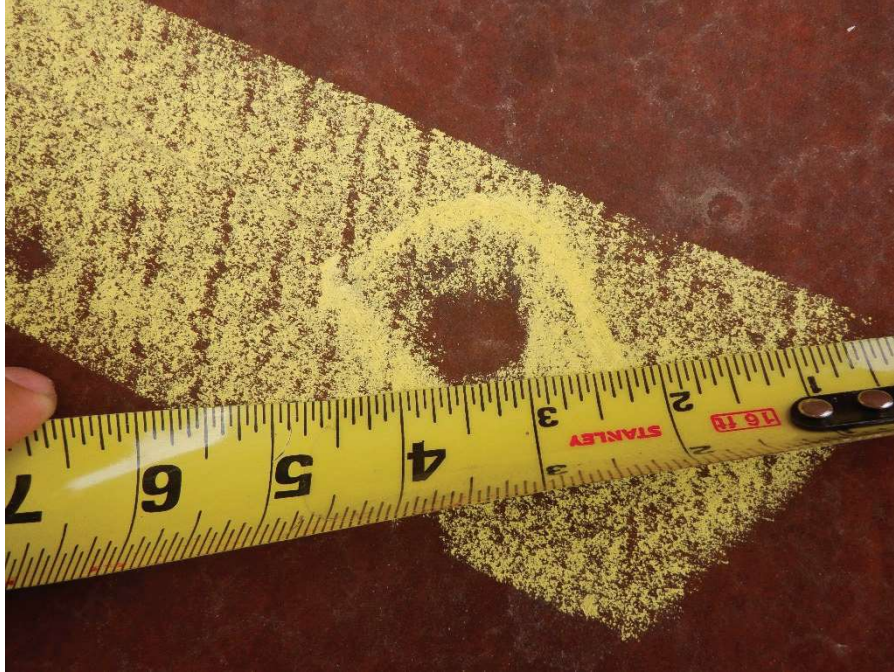
View of a spherical hail-caused indentation approximately 0.8 inches in diameter.

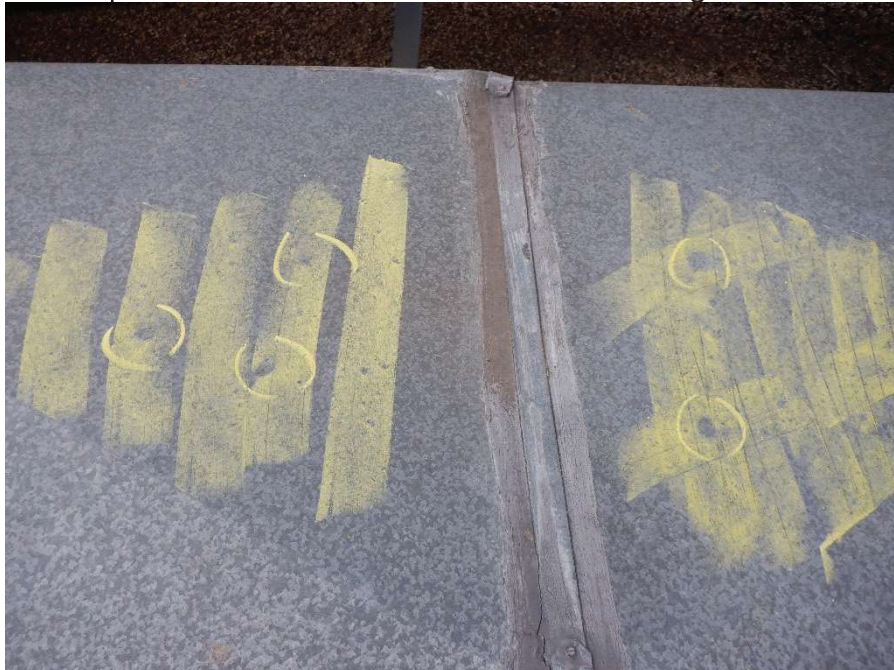
B-HCE Report Number 44-22003 – Pendant Properties, LLC Attachments

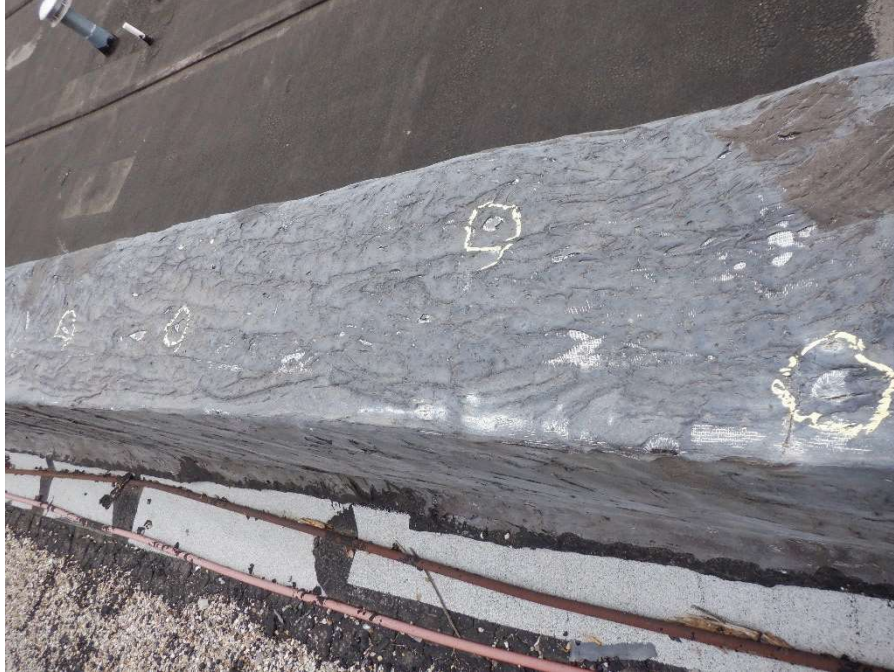
View of the spherical hail-caused fractures in the bitumen cover on the parapet.

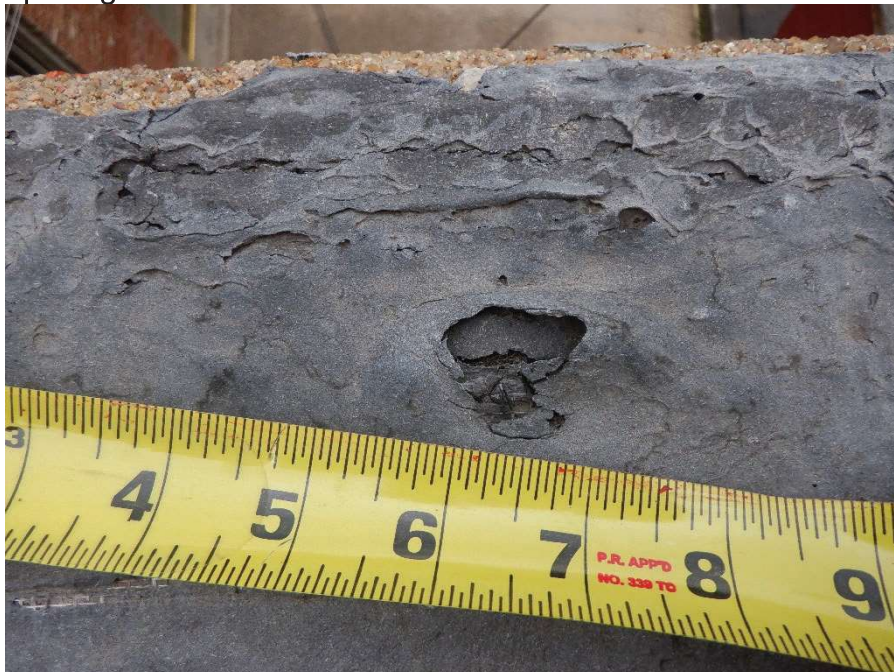
B-HCE Report Number 44-22003 – Pendant Properties, LLC Attachments

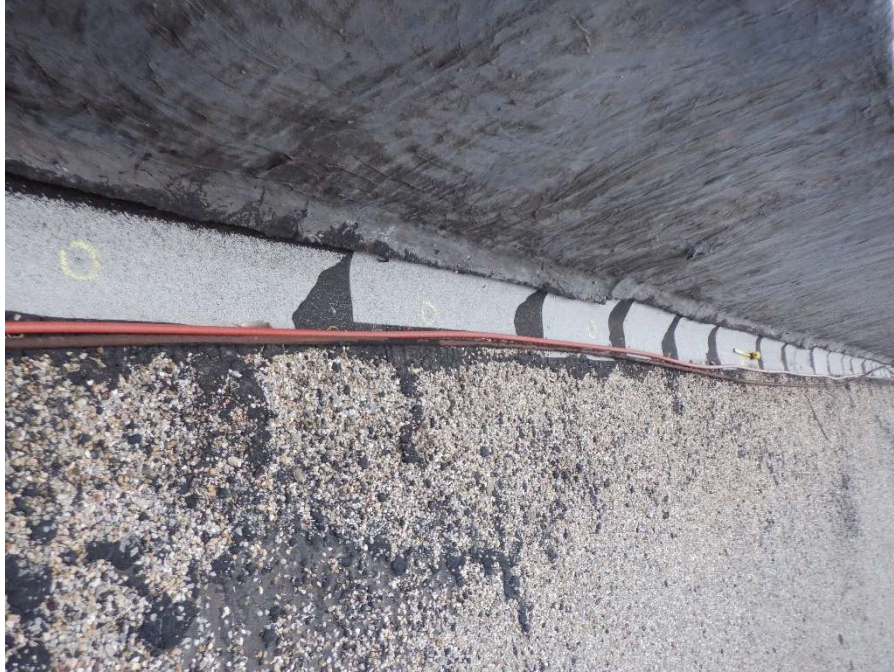
View of the spherical hail-caused impact marks with displaced granules and exposed bitumen on the mod-bit parapet wall curb.

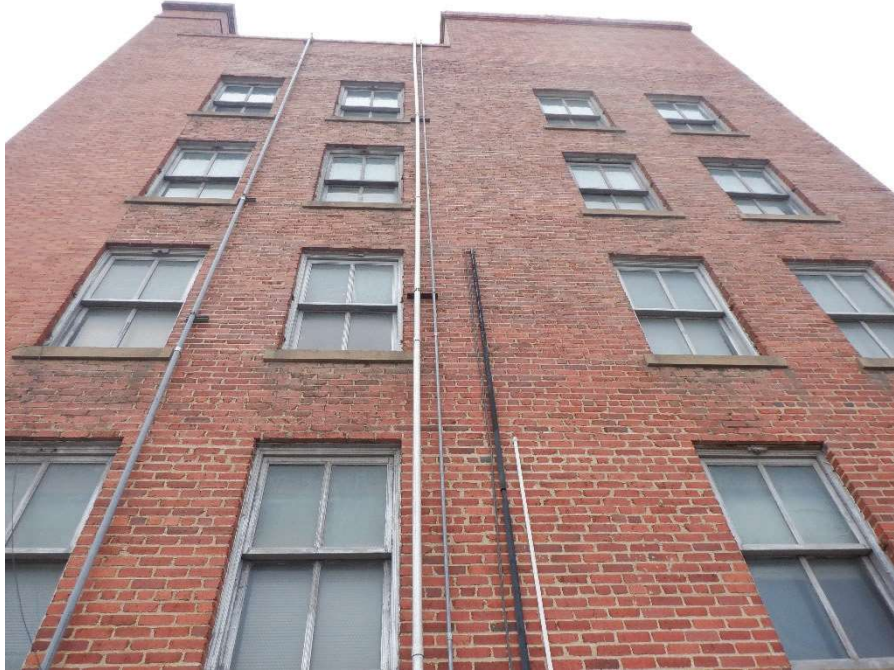
View of the east-facing side of the building where window frames were damaged.

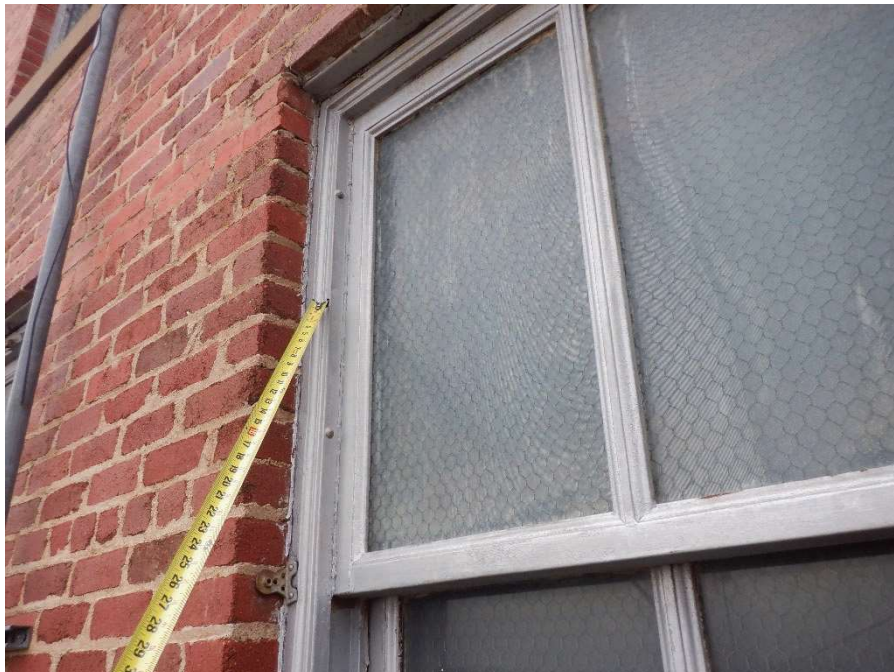
**B-HCE Report Number 44-22003 – Pendant Properties, LLC
Attachments**

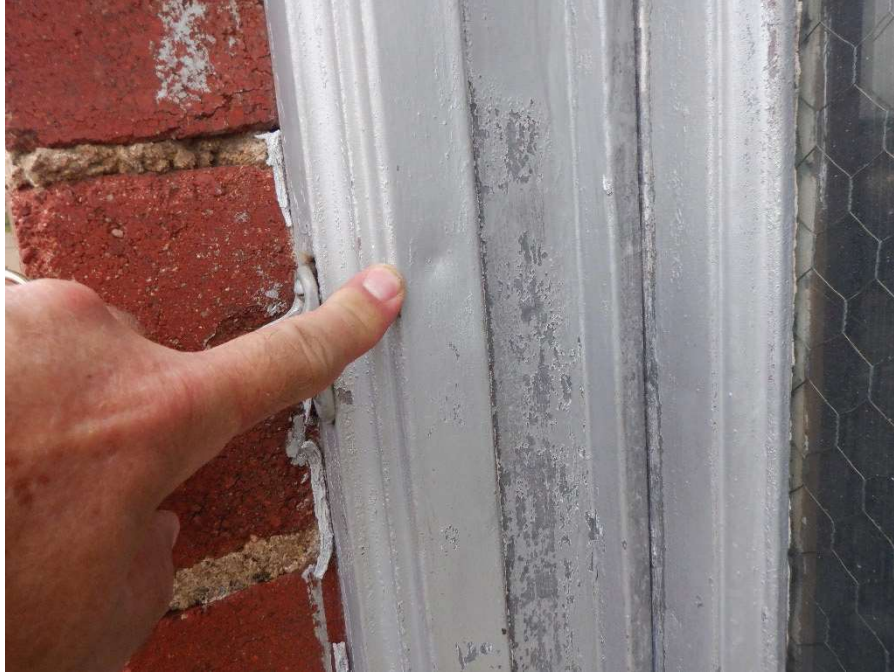
View of a spherical hail-caused indentation on the north-facing fire rated metal window frame.

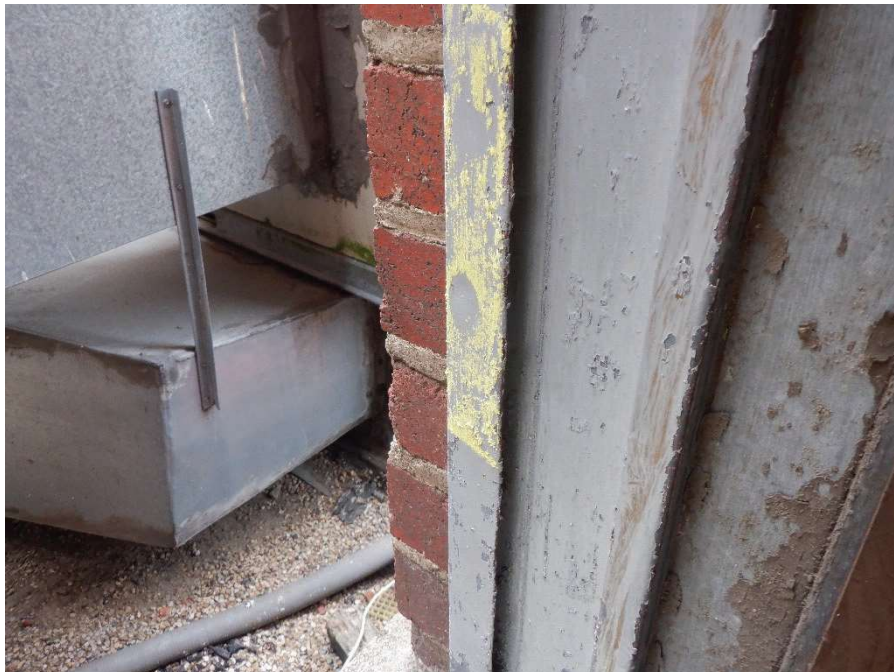
**B-HCE Report Number 44-22003 – Pendant Properties, LLC
Attachments**

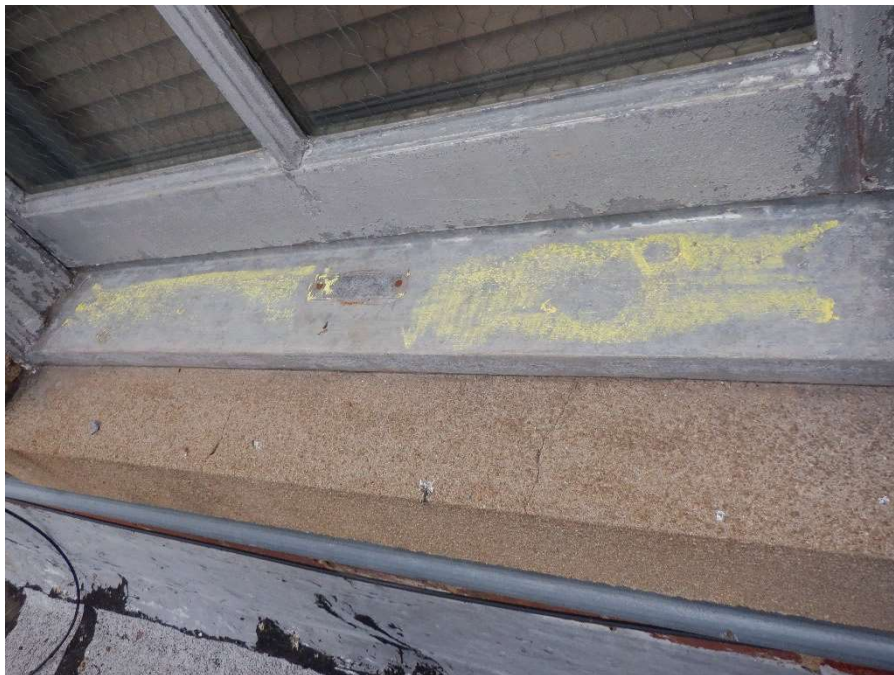
View of the hail-caused indentions on the fire rated metal window sill.

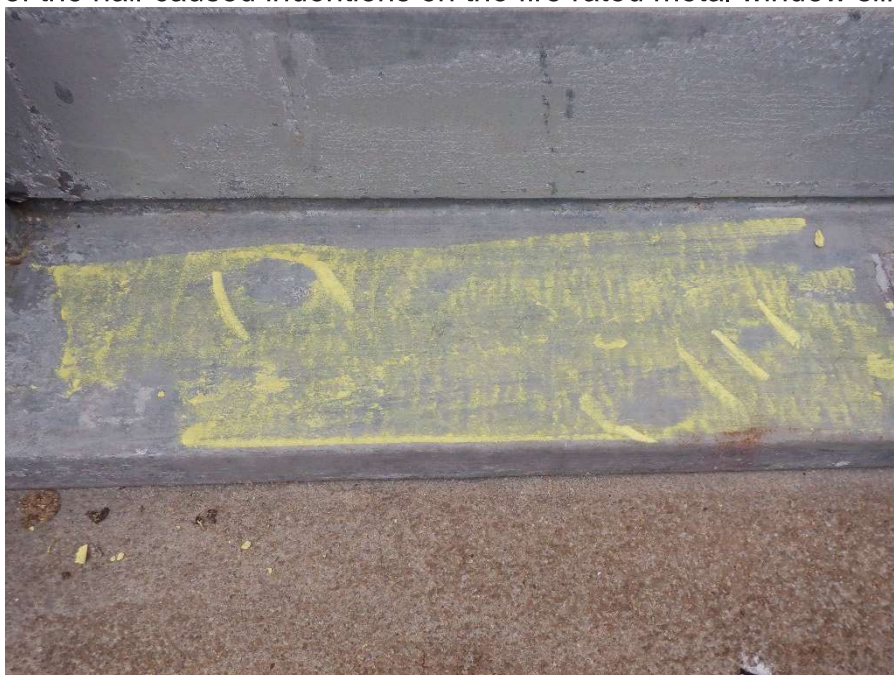
B-HCE Report Number 44-22003 – Pendant Properties, LLC Attachments

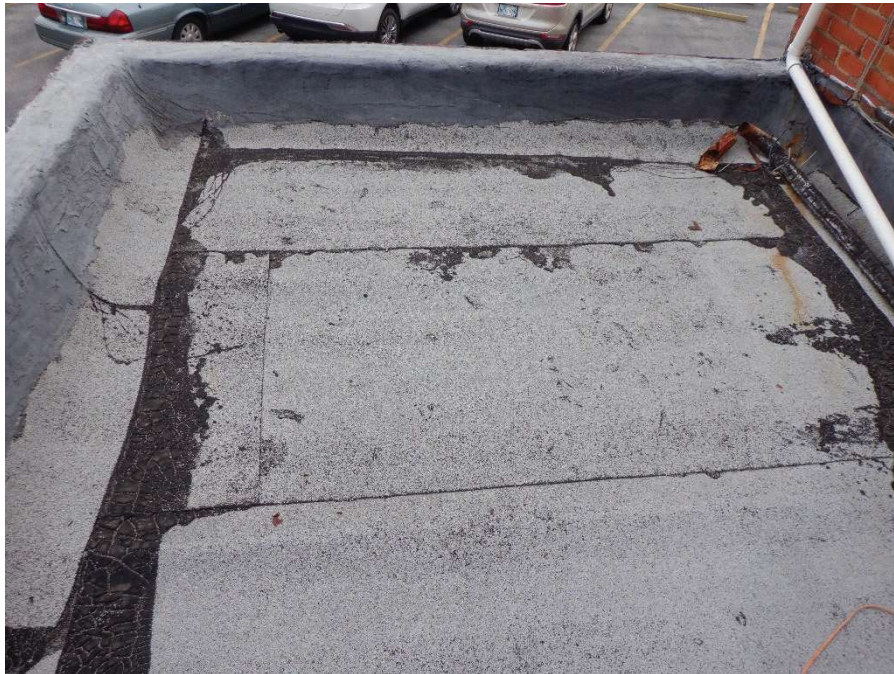
View of the mod-bit roof with bitumen parapet covering over the storage area.

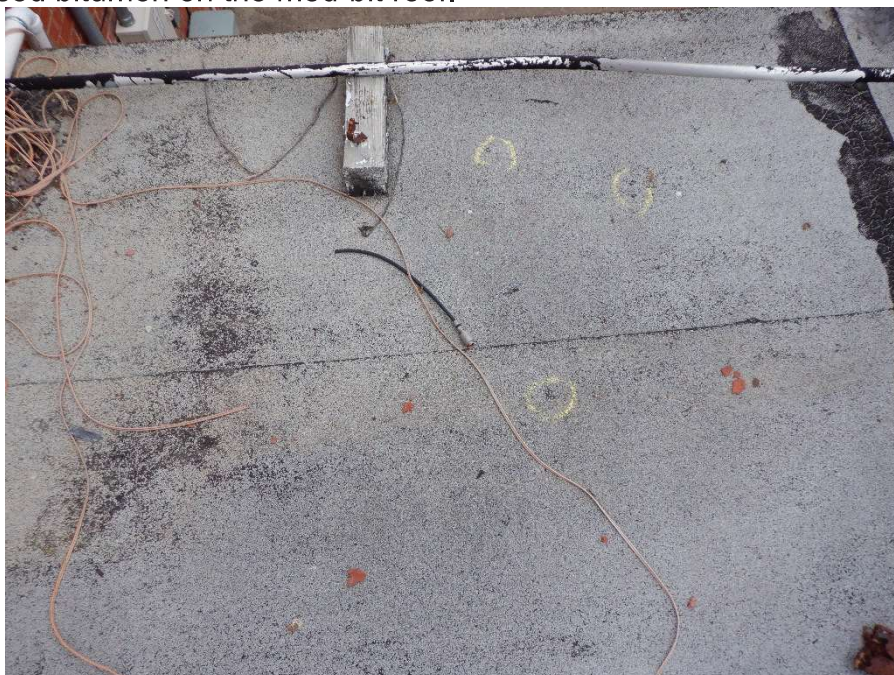
B-HCE Report Number 44-22003 – Pendant Properties, LLC Attachments

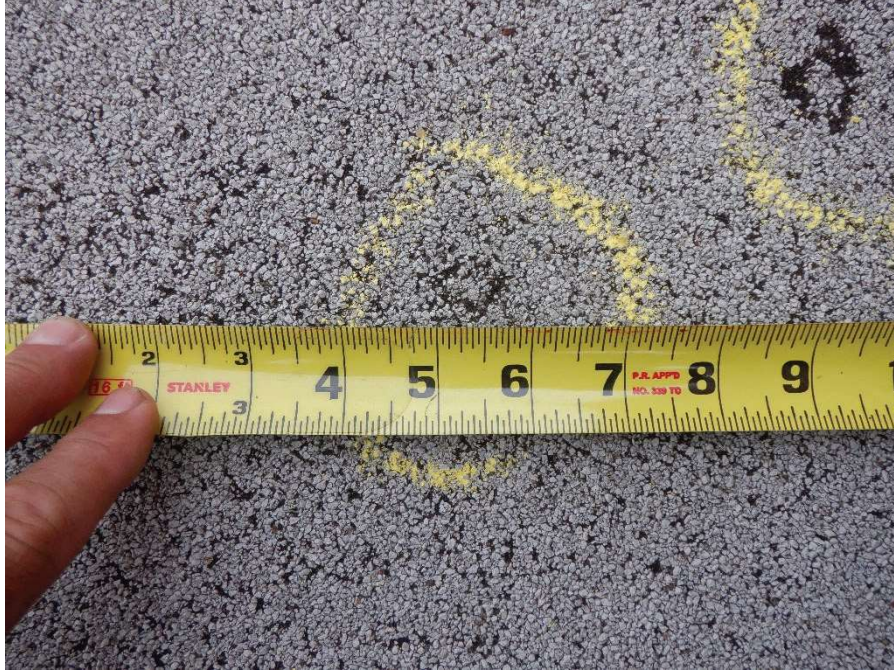
Close view of the spherical hail-caused marks approximately 1.0 inches in diameter with displaced granules and exposed bitumen on the mod-bit roof.

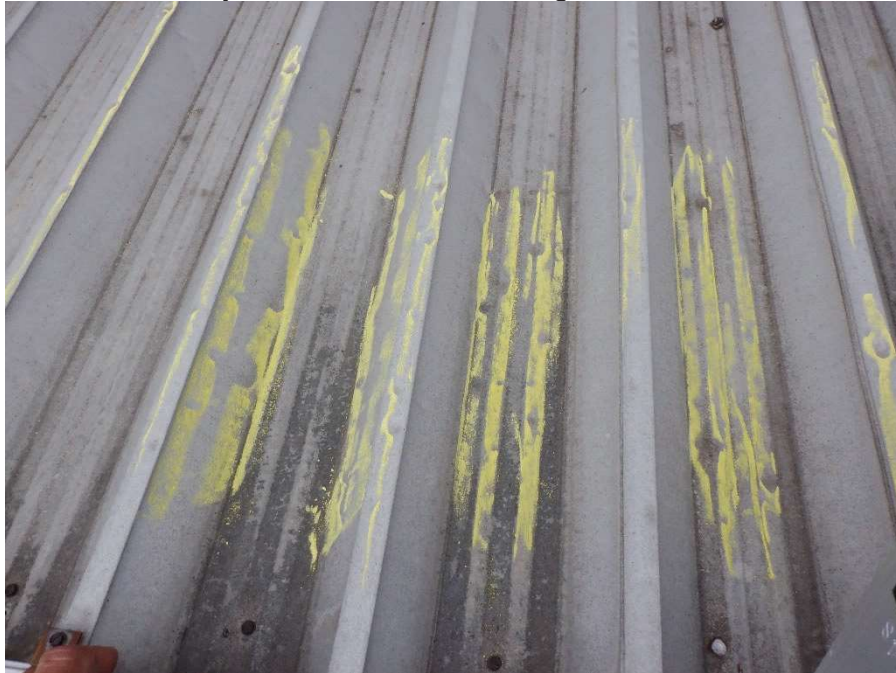
View of the spherical hail-caused indentations in the metal panel awning over the south hallway entrance. Note the larger indentations are not soiled.

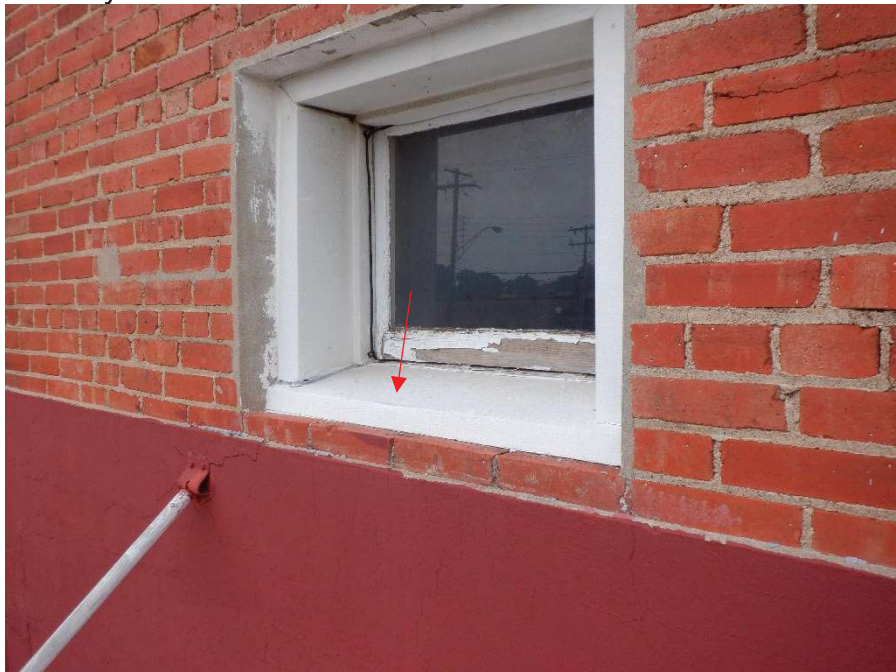
View of a spherical hail-caused indentation in the window sill above the south hallway entrance.
